CEMENT-TREATED AND CONCRETE PAVEMENTS:

their applicability in Finland and elsewhere

THE FINNISH ASSOCIATION OF
BUILDING MATERIALS INDUSTRY
ROADS AND WATERWAYS ADMINISTRATION

TVH 723869 / 1989

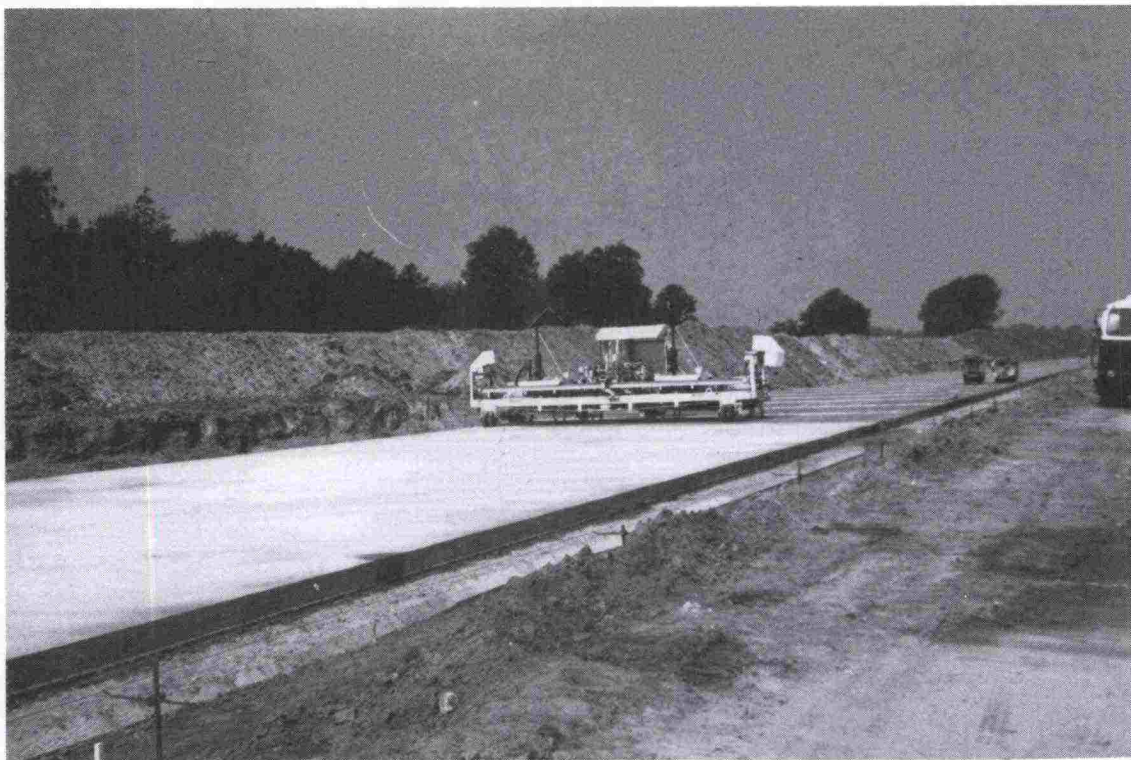
FIGURE B1-17. Working phases:
sawing transverse joints

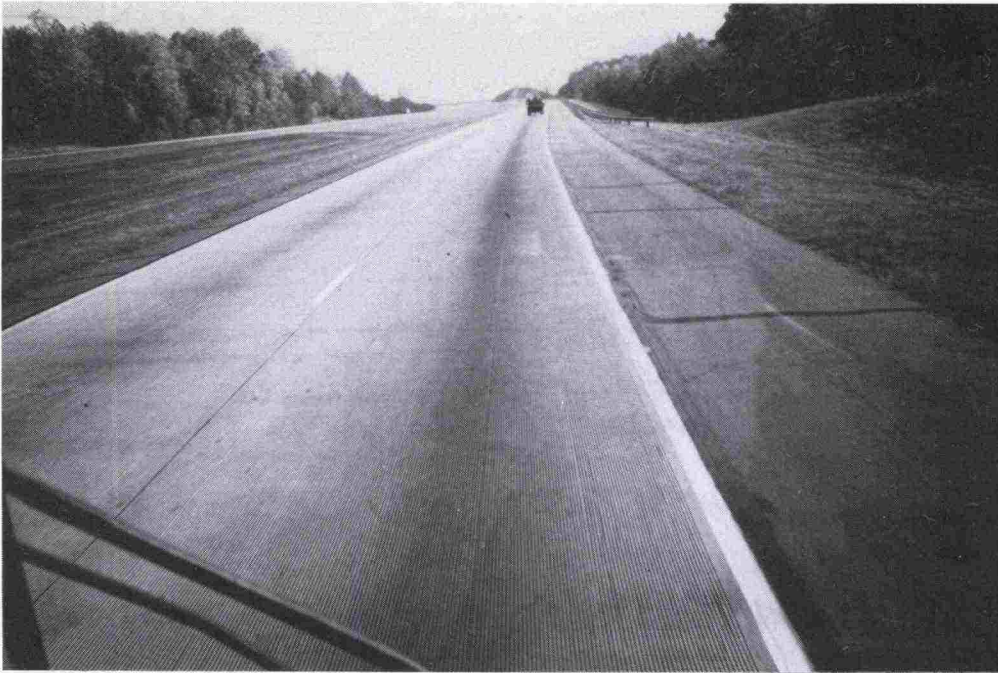
FIGURE B2-19 a. Concrete pavement repaired by diamond grinding in Alabama in the United States

Diamond grinding has been used to improve evenness of concrete pavements in the United States since 1965. The method has been developed into a reliable routine method which meets or even exceeds the evenness values of a new pavement (Figure B2-19 a, b).

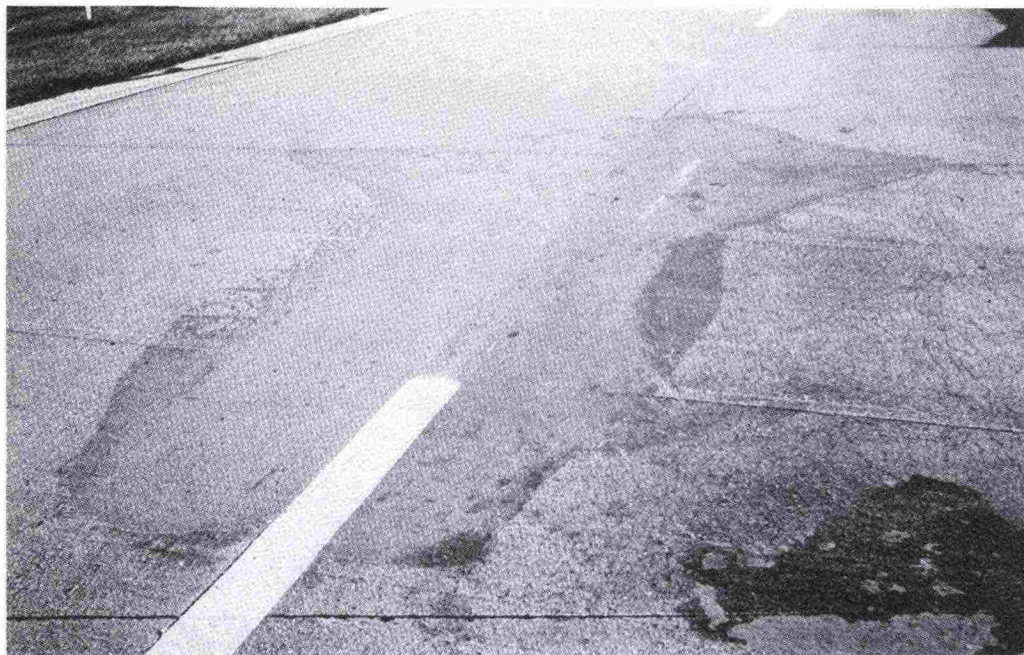
FIGURE B2-21. A thin epoxy overlay as a repair method of an open pavement surface

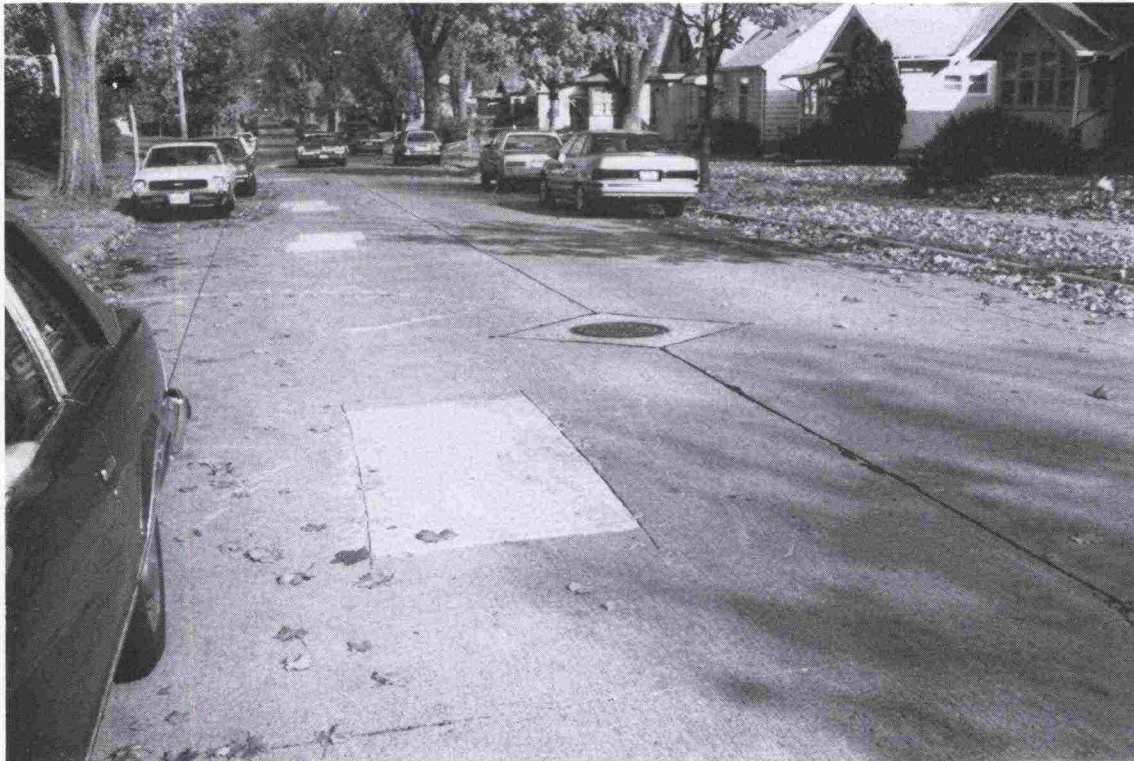
FIGURE B2-32. An old concrete-paved urban road in Minneapolis, repaired by full depth patching (photo JR/1987)

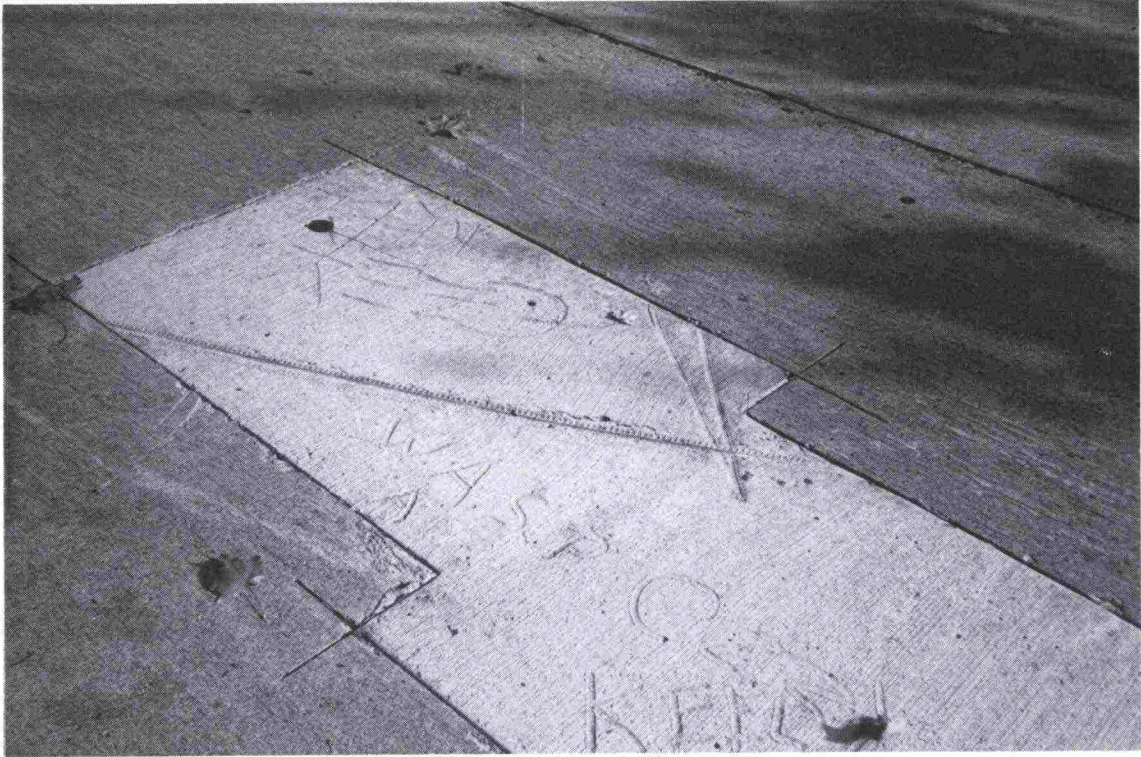
FIGURE B2-33. A detail of a patched street pavement, Minneapolis

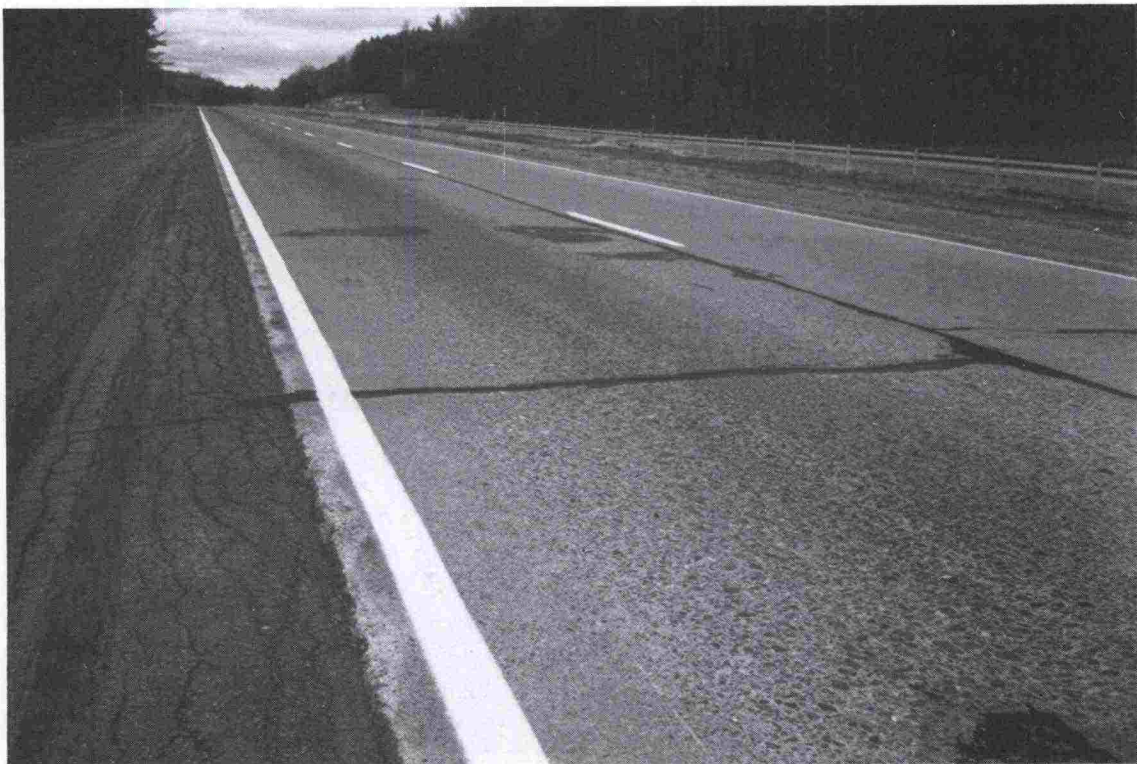
FIGURE B2-36. A worn-out, old concrete pavement, an asphalt shoulder, Thruway 87, New York

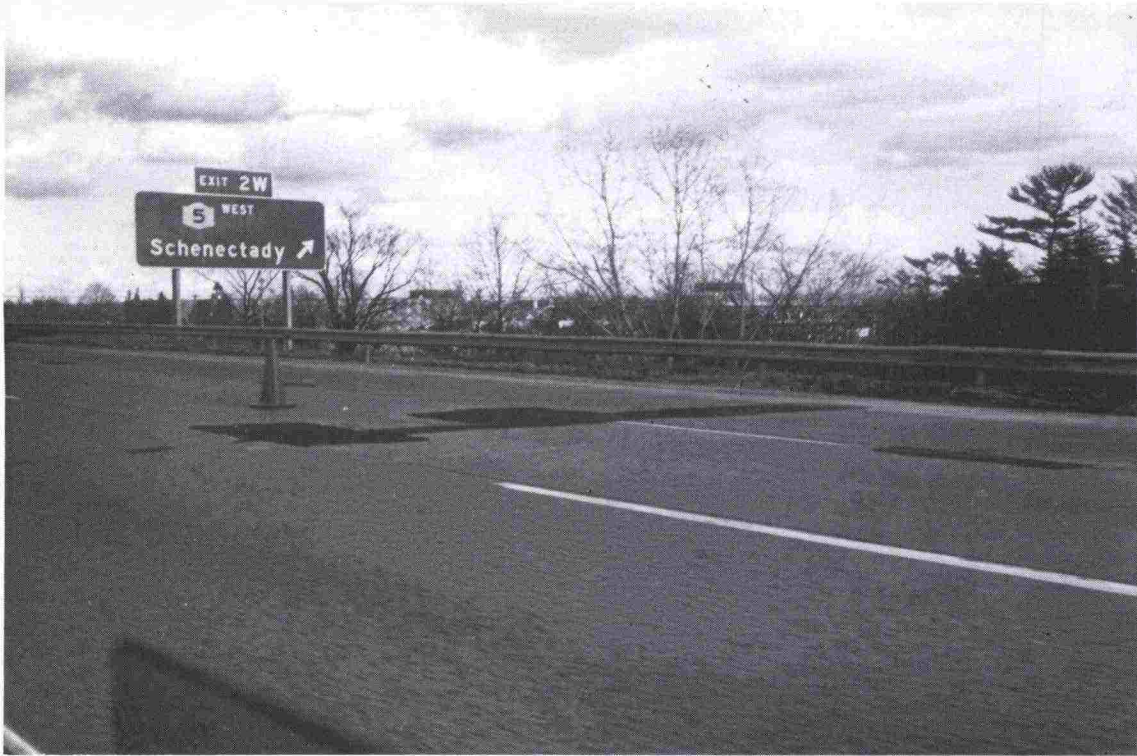
FIGURE B2-37. Asphalt patches on a concrete pavement, Albany, New York

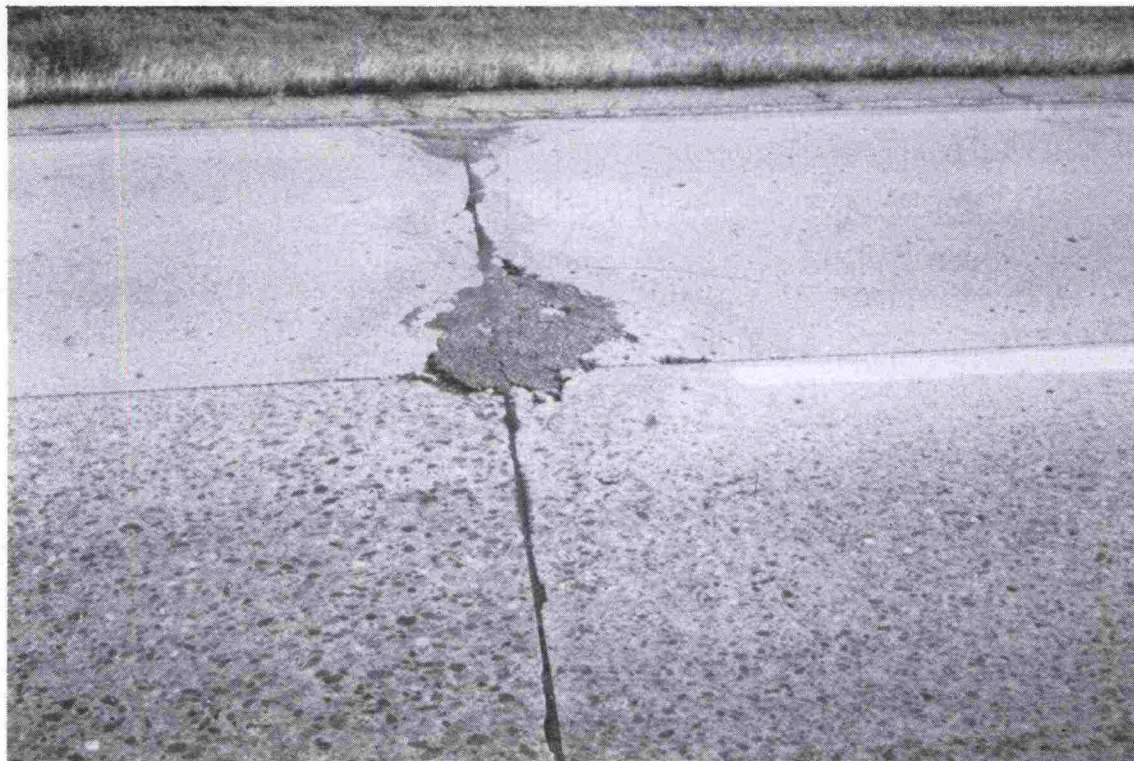
FIGURE B2-39. Severe D-cracking in the pavement, Minnesota

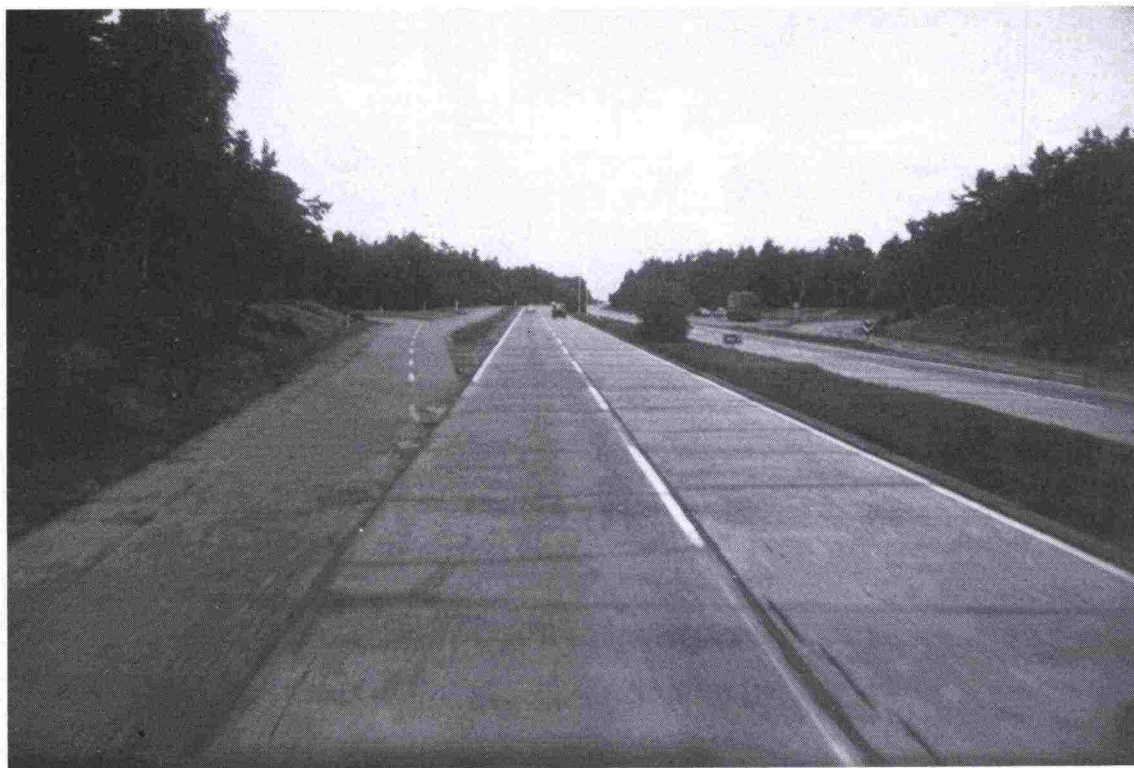
FIGURE B2-41. Concrete pavement built in the German Democratic Republic in the 1930s (Berlin-Dresden). Cracking and warping of slabs occur, the service level reduced

Concrete pavements built on main roads in the 1930s are still trafficked in the German Democratic Republic (Figure B2-41). It has been necessary to decrease the speed level of these roads due to regular faulting of joints, otherwise the slabs are in a considerably good condition. Rehabilitation of the worst sections is undertaken as a repavement by removing the old pavement.

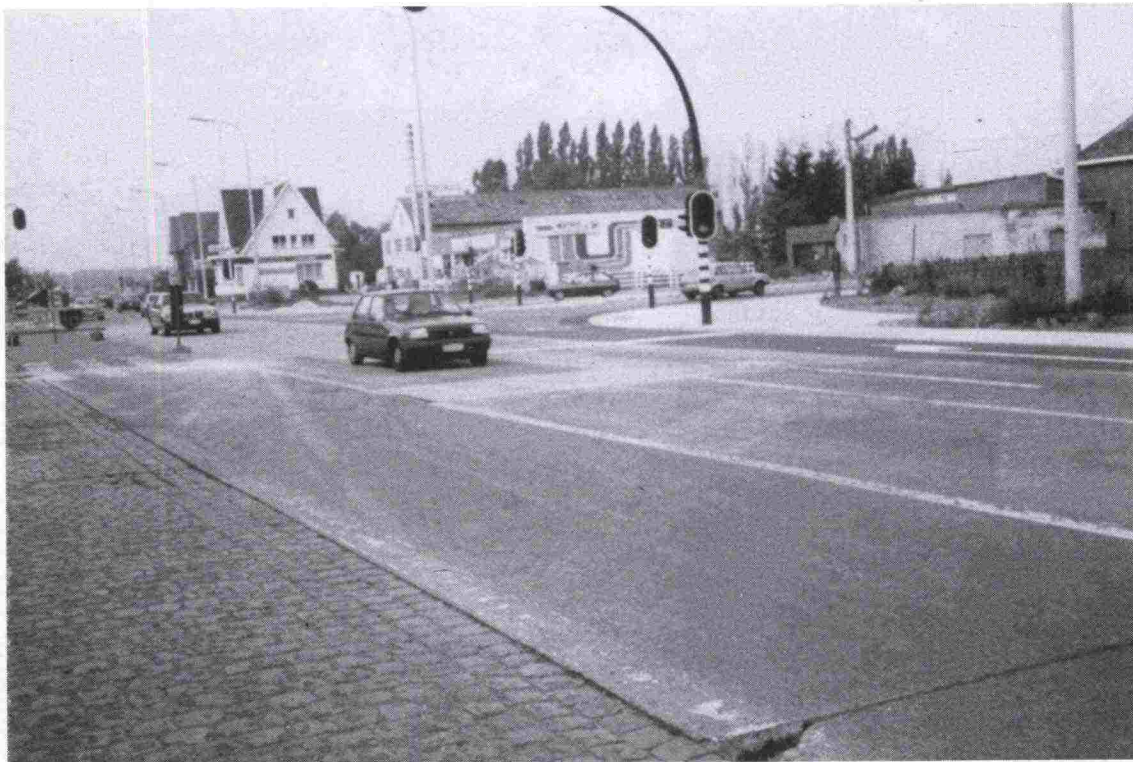
FIGURE B2-42. An old concrete pavement on regional road N2 in Belgium. Hitting joints and cracking have been repaired by replacing slabs (photo JR/1987)

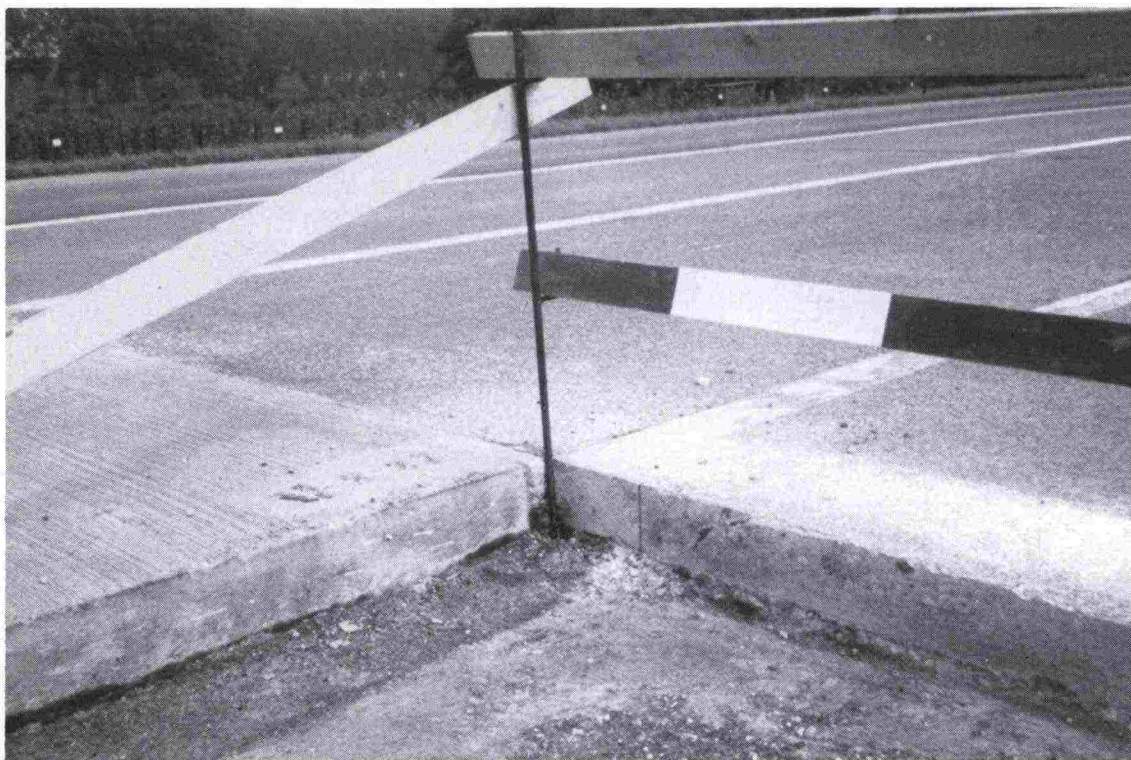
FIGURE B2-43. Full depth repair
N2 Halen-Hasselt, Belgium

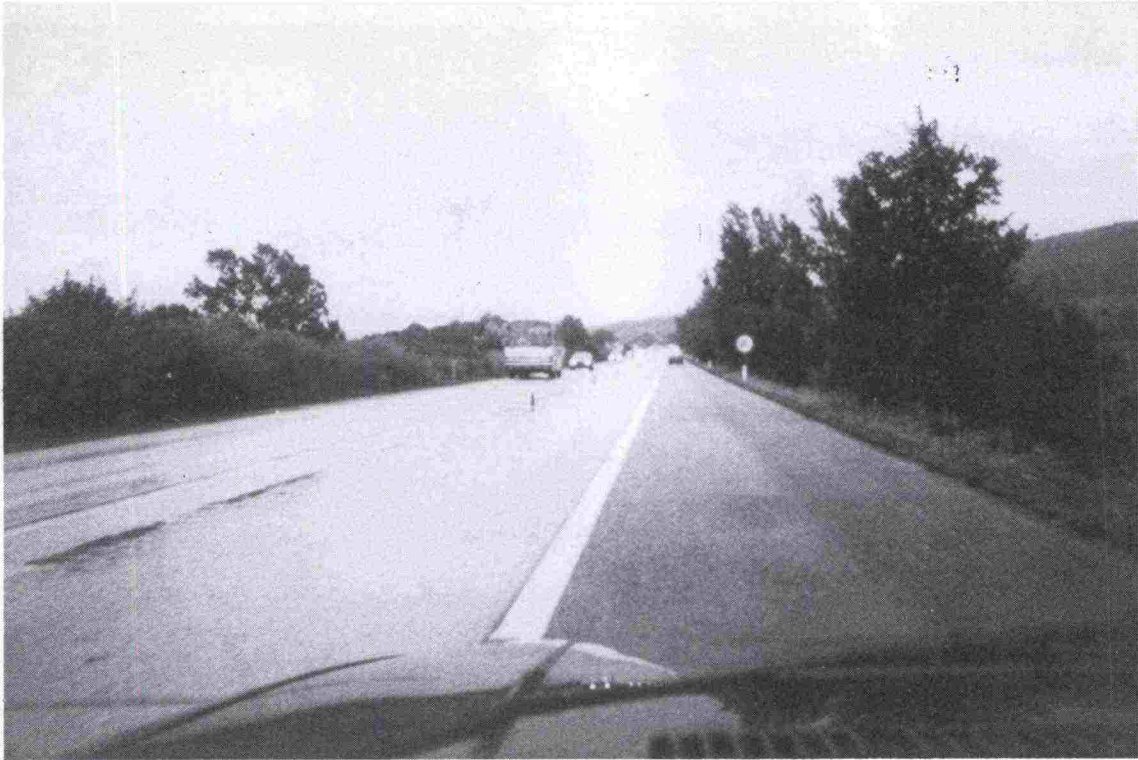
FIGURE B2-45. A rutted concrete pavement, ponds on the road, A1 Melk-Wien, Austria

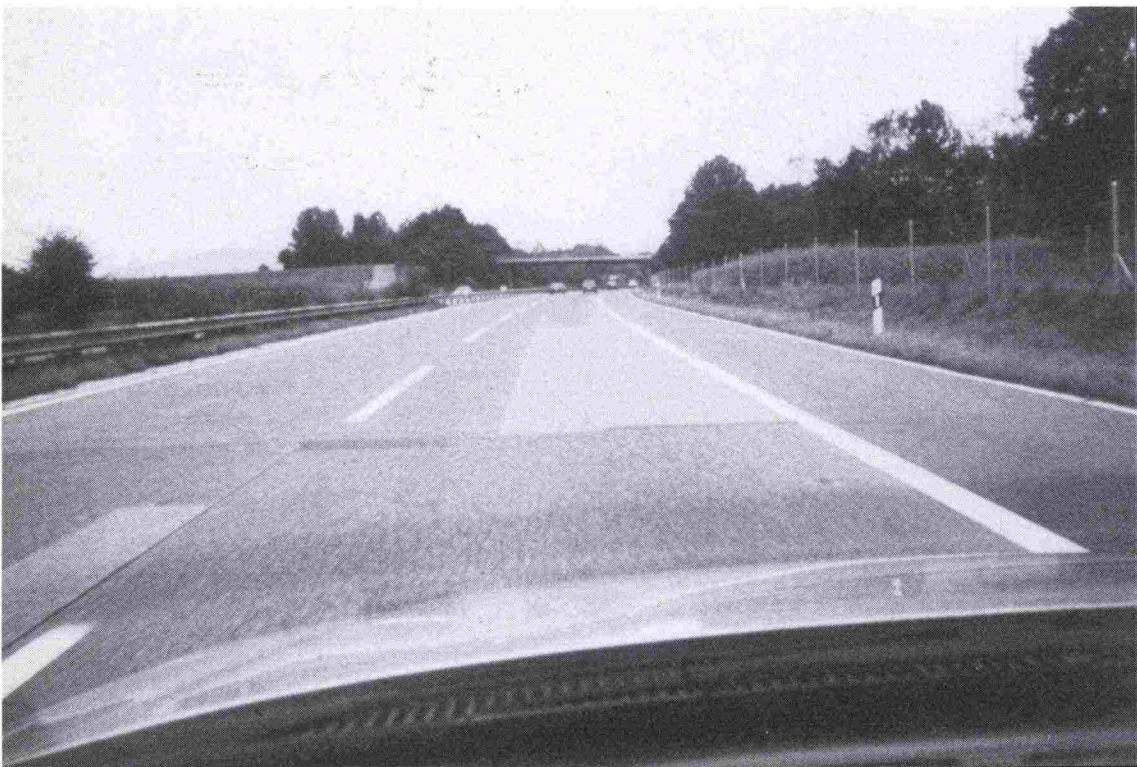
FIGURE B2-49. Concrete pavement rehabilitated by replacing slabs, N1, Aarau, Switzerland

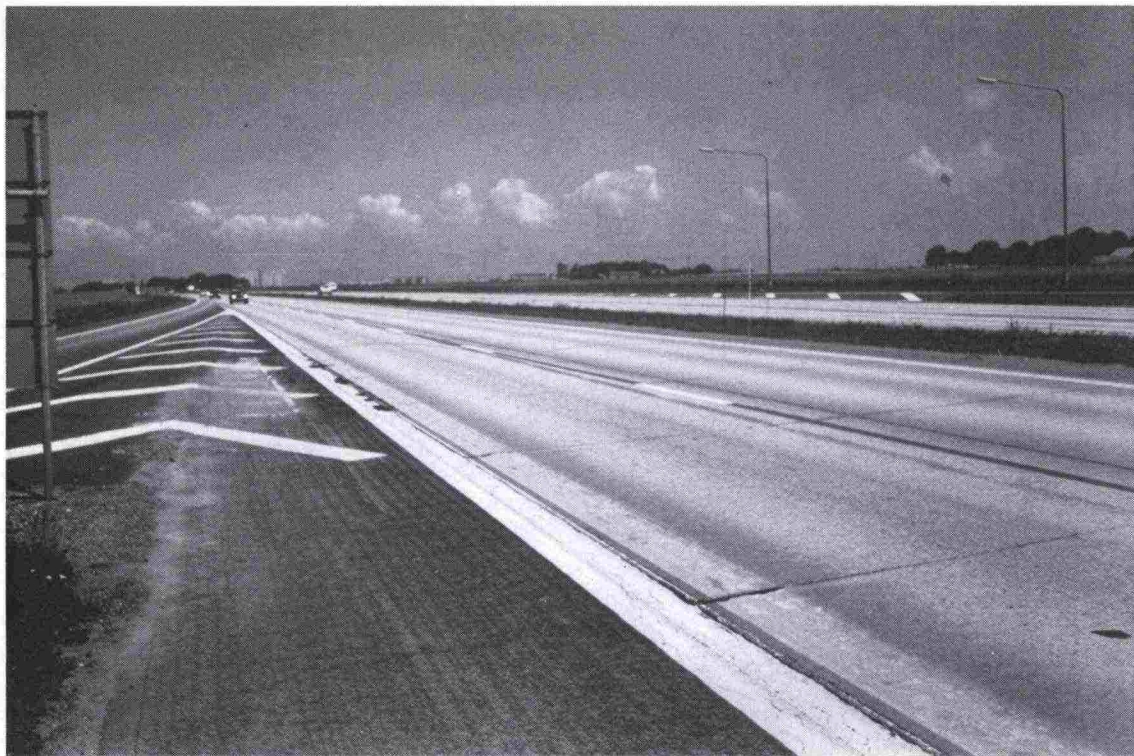
FIGURE B2-51. Concrete pavement built on the road section Vellinge-Malmö, Main Road E 6, east of Malmö in Sweden in 1972. Ruts of about 20 mm, joints have broken at ruts here and there, condition and driving comfort good (photo JR/1988)

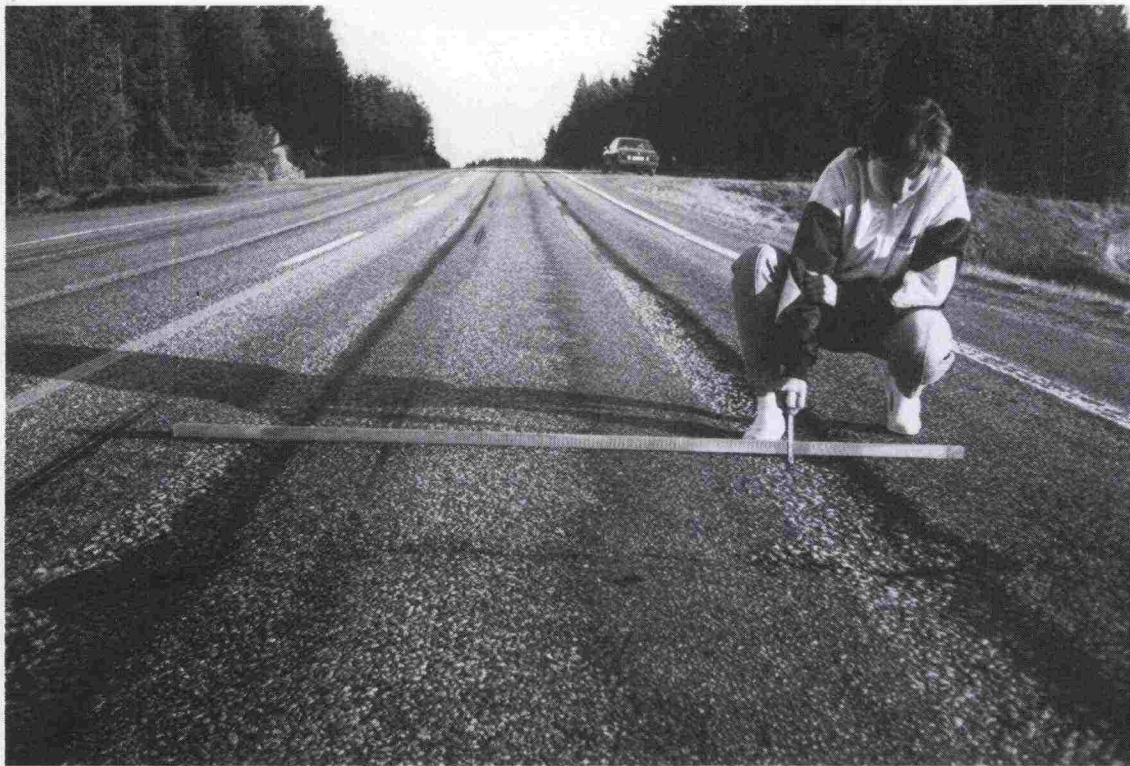
FIGURE B3-24. A rutted asphalt pavement, spring 1988 (mr II 41, Pöytyä, ADT 2200, rut repaired section)

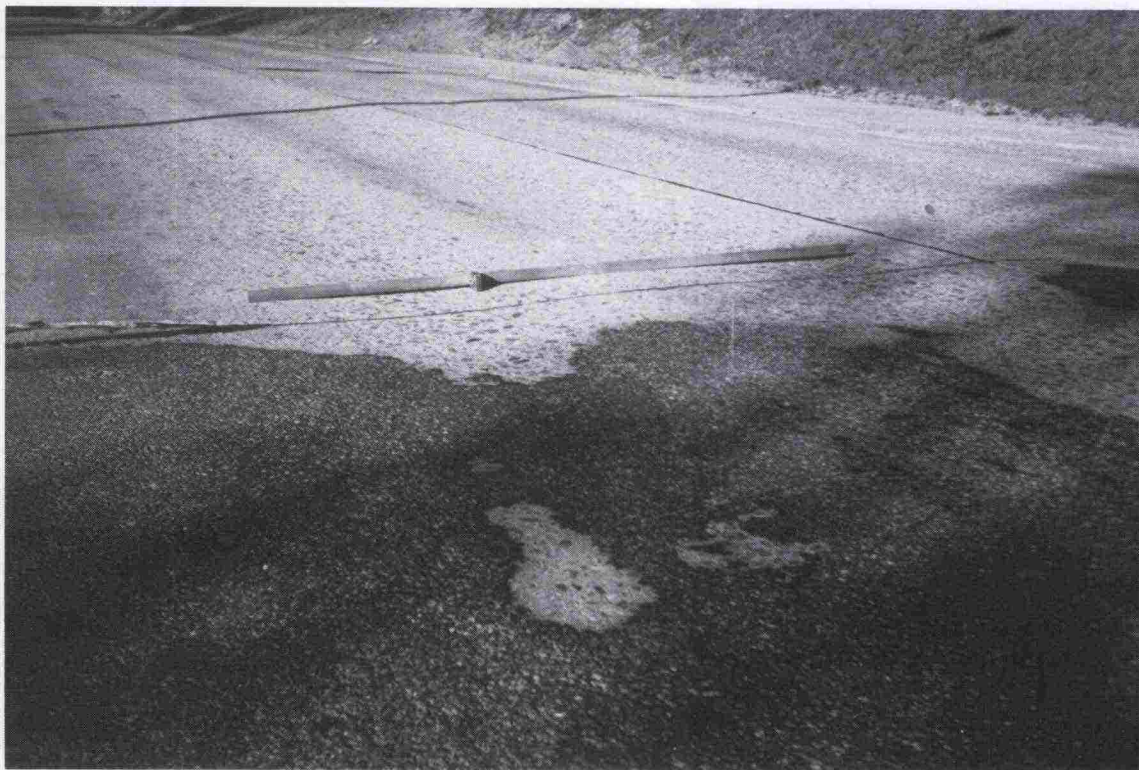
FIGURE B3-25. A rutted concrete pavement, spring 1988 (Skräb-börentie, Parainen, ADT 2000, built in 1958)

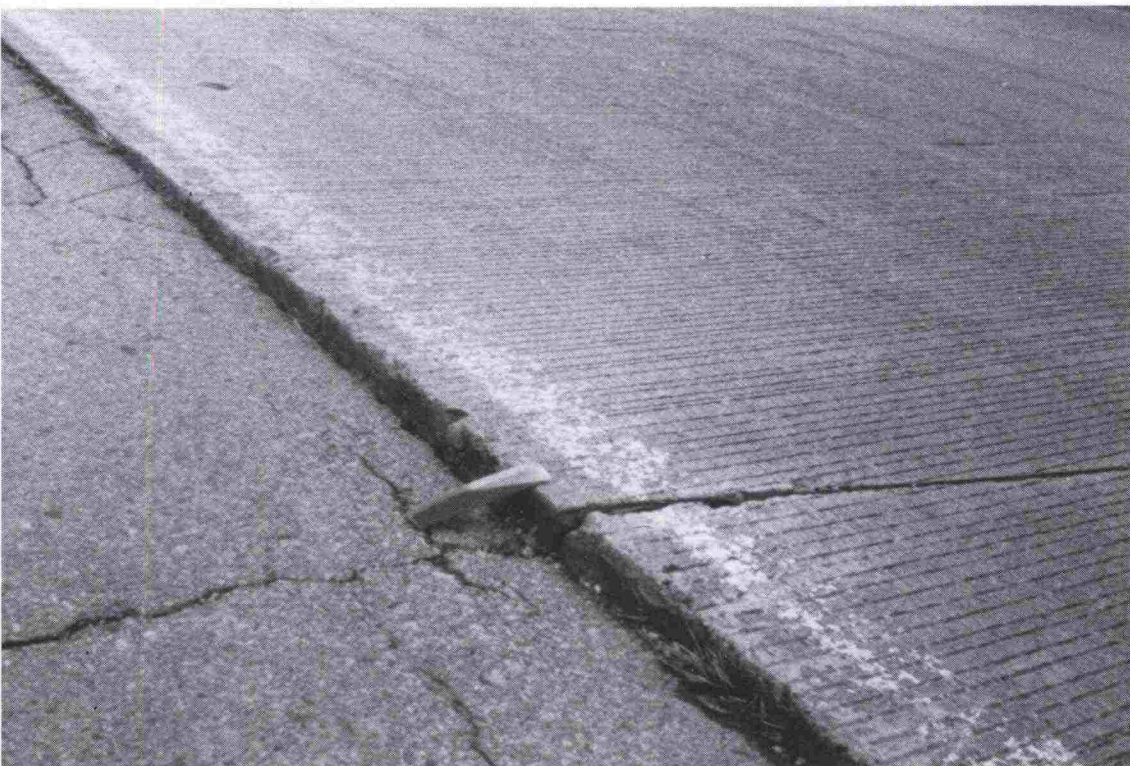
FIGURE B4-18. Faulting between shoulder and pavement, Wisconsin USA

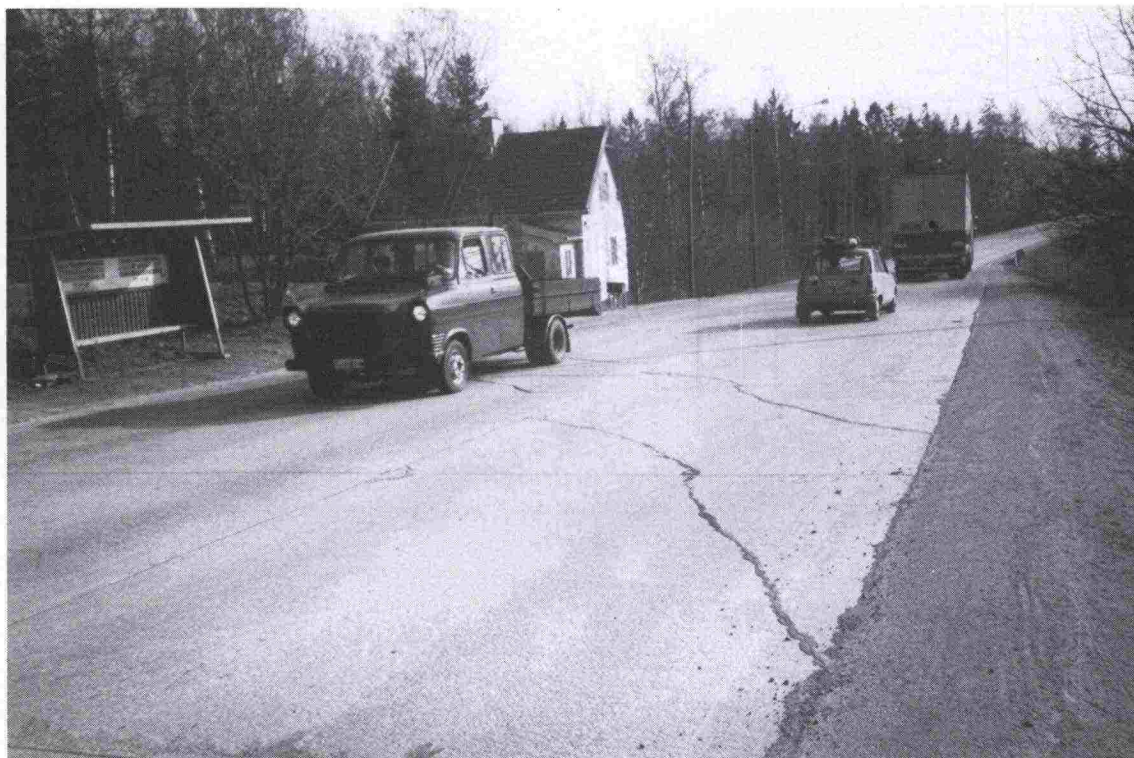
FIGURE B4-32. Frost damage on Kalkkitie in Parainen (concrete pavement from 1982)

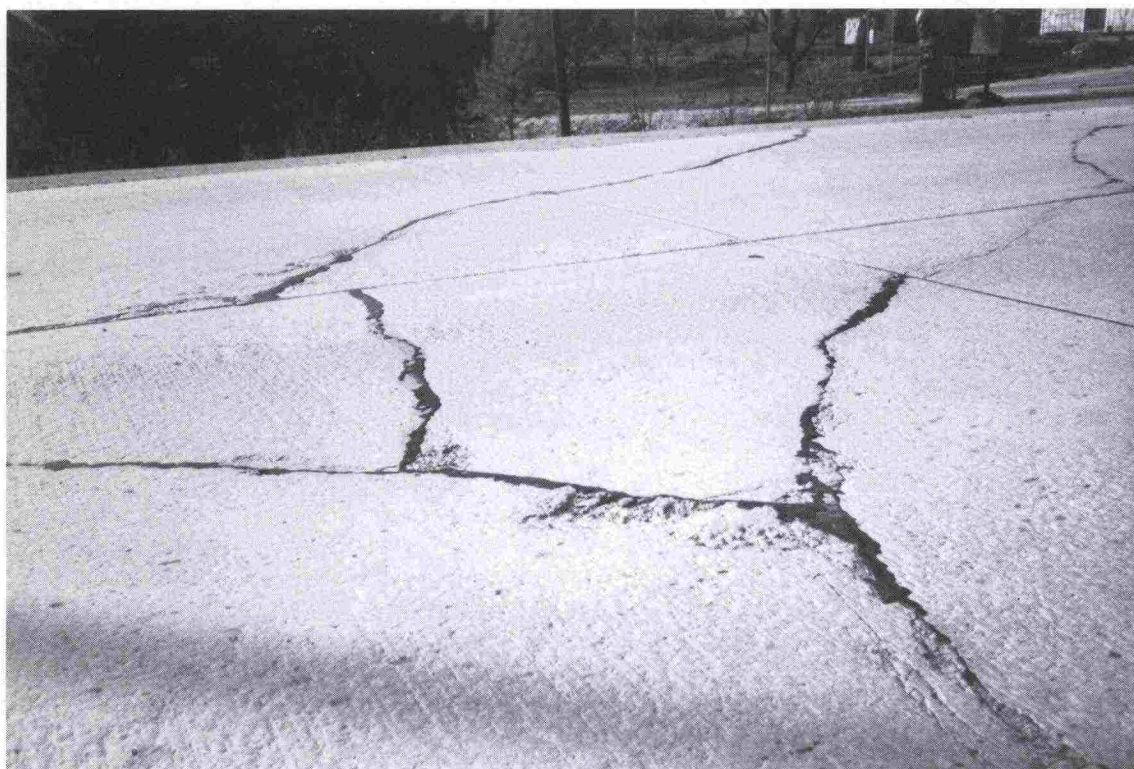
FIGURE B4-33. Frost damage on Kalkkitie in Parainen, a slab damaged by frost

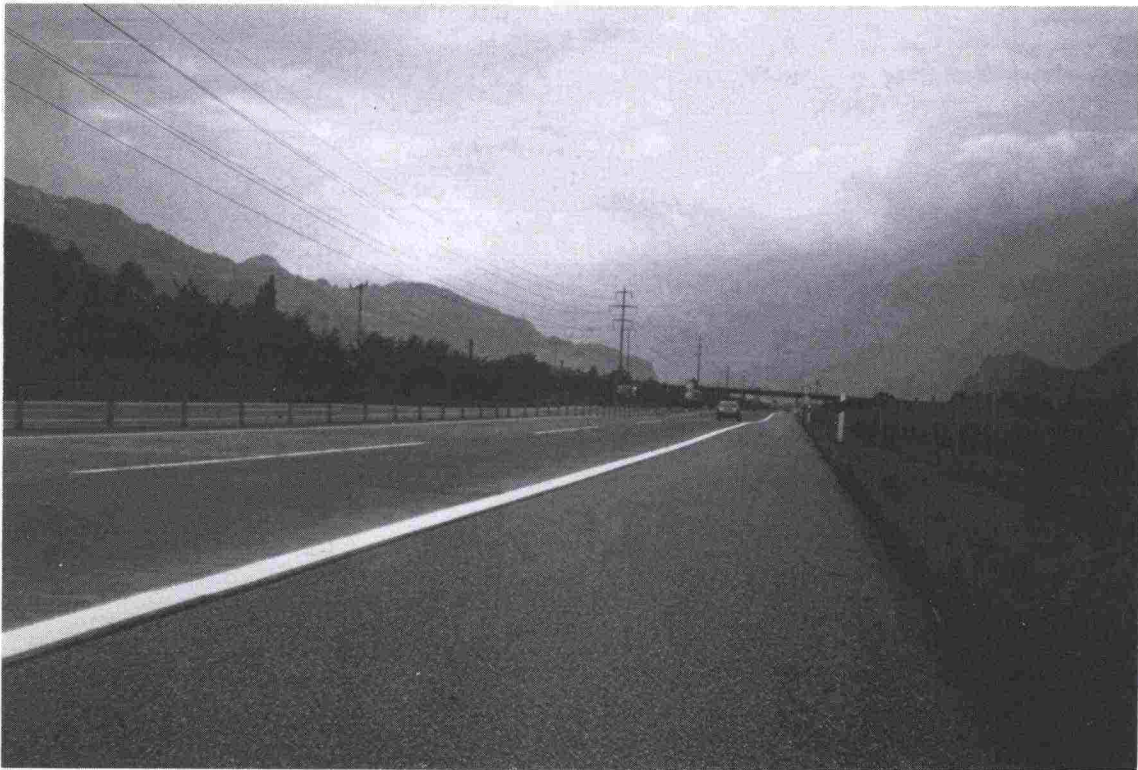
FIGURE B5-20. N3 Flums-Sargans, a general view of the settled embankment in Switzerland. The concrete pavement in an excellent condition in 1987

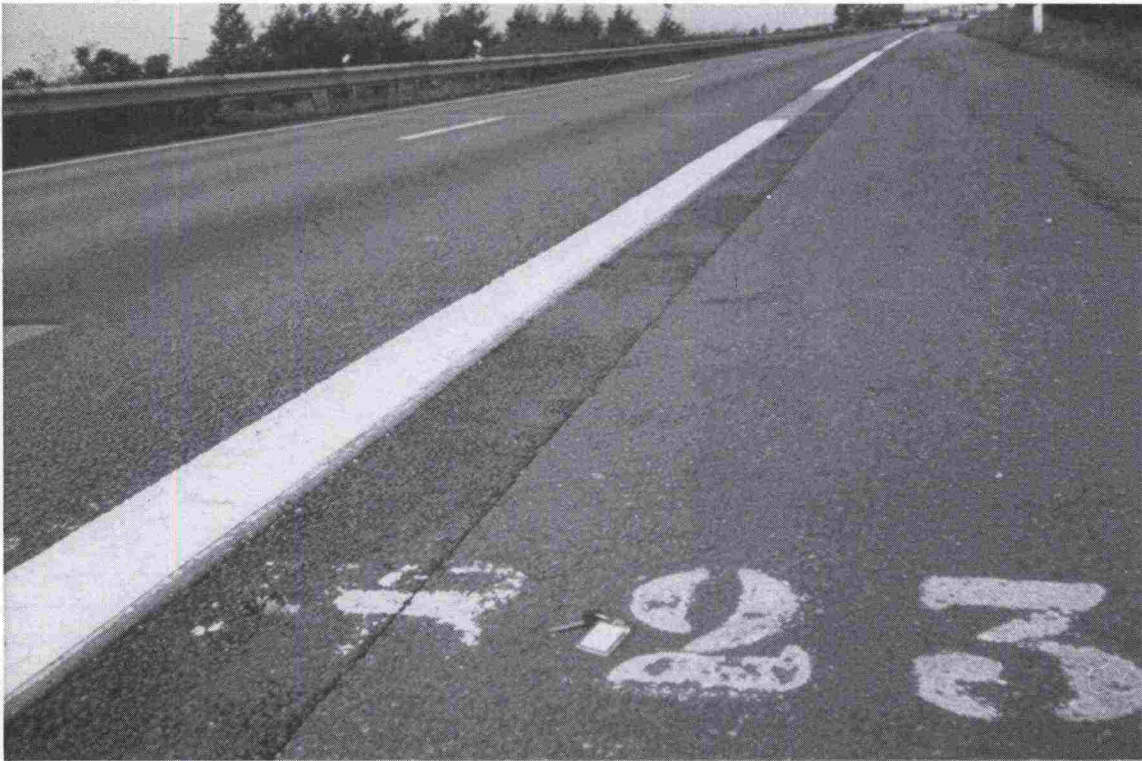
FIGURE B5-21. A concrete pavement in France damaged due to compaction of the embankment; rehabilitated by grinding and surface treatment (photo JR/87)

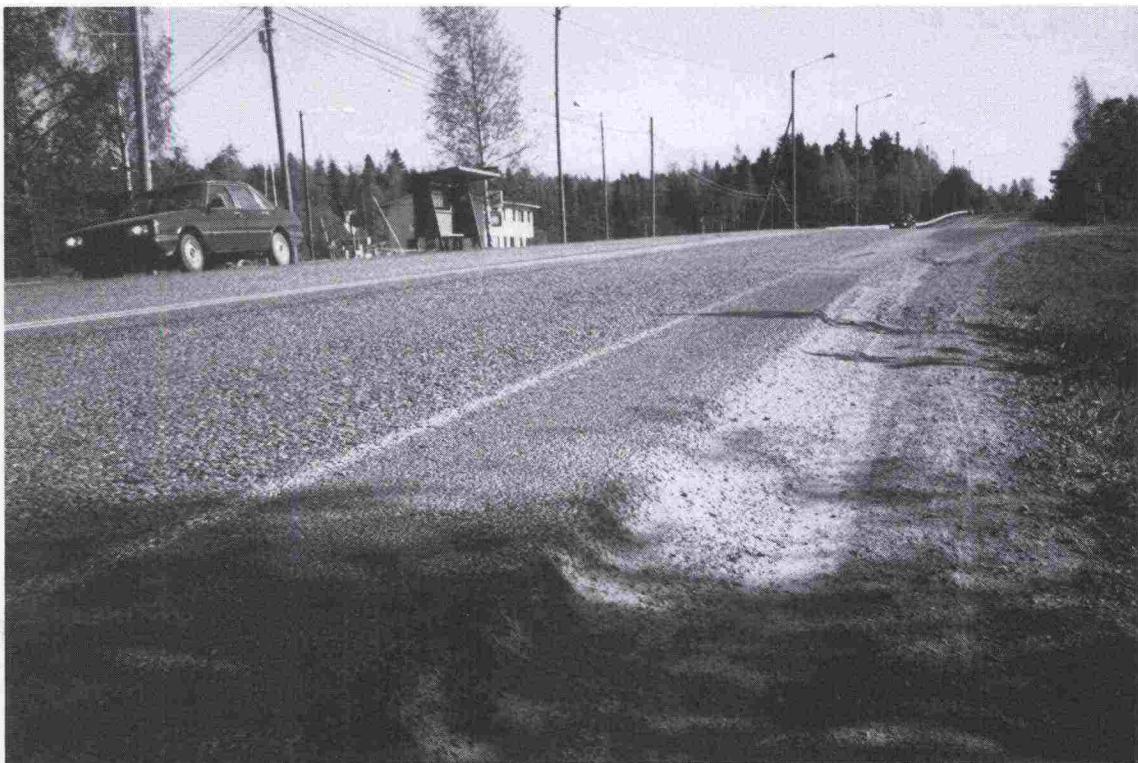
FIGURE B5-22. Consolidation settlements on Paraistentie (concrete pavement 1959, asphalt treatment 1984), Finland
